Manhole Inspection Summary

Manhole # S23GG2011MH

Insp Date: **10/1/08 9:34 AM**

Location Address: **911 BELLEMORE RD**

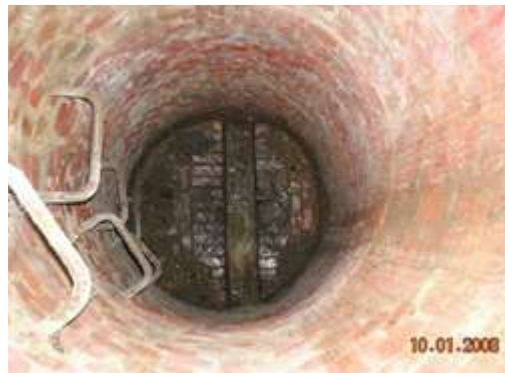
Top View

Evidence of surcharge - Bench debris.

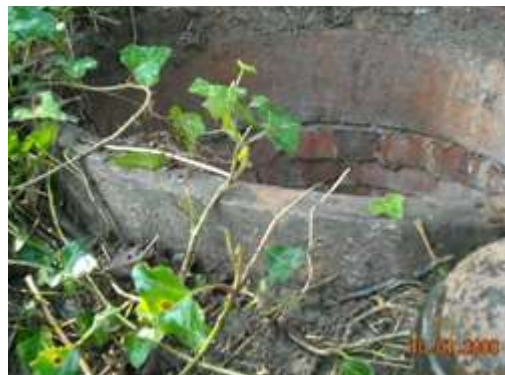
Above grade side

SLOPE SIDE OF HILL

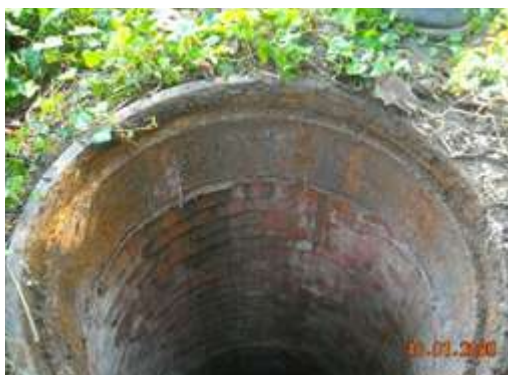
Defect

Frame leaks. Adjustment, Corbel and Barrel infiltration.

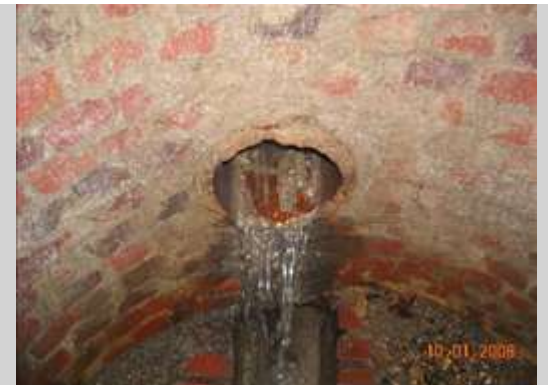
8 in. Circular Gravity Sewer Pipe In @ 6 O'Clock

Deposits: ☐ None ☐ Mud ☐ Sludge ☐ Debris ☒ Grease

Silt Depth: **2** (in.) Deposits Extent: **Medium**

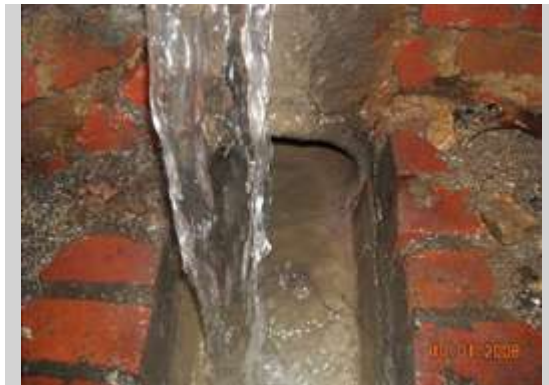
Drop In @ 6 O'Clock

Drop Condition: **Clogged**
